Repair of the 1851 Wrought Iron Gates and Brownstone Column

HANOVER TOWNSHIP LANDMARK COMMISSION

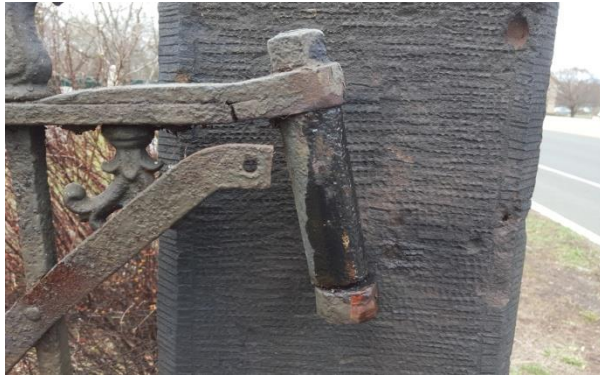
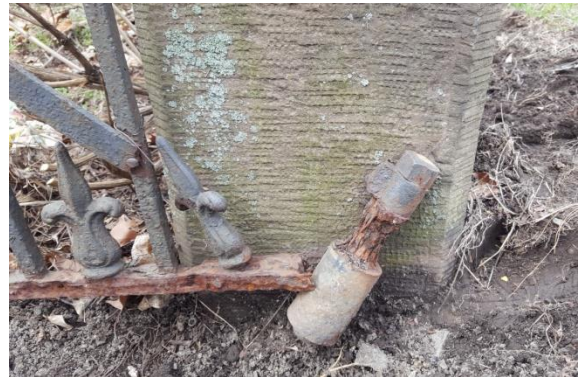
One of three gates with rusted, frozen, and broken hinges—Top and bottom hinge illustrated.

In 2016, after not being used for over half a century, it was discovered that the historic brownstone gate post was hit by a vehicle and broken at the base, one wrought iron gate was wrecked by the accident, and all gates were frozen open and inoperable from rust.

- ▶ In 2017, the gates were removed and the post was repaired.

Landmark Commissioner, Len Fariello, lifted the post with his farm tractor, and three holes were drilled into both sides of the break, 1-foot rebar steel pins were driven into the base of the post while the top of the post was lowered onto the pins and the break was sealed with epoxy.

- ▶ In 2018, former Whippany resident Pat Kruger machined and replaced the rusted hinge extensions; he also sandblasted, repaired, and powder coated the gate, and installed the refurbished gates back onto the hinge pins drilled and anchored in the brownstone columns.
